## **PHASE I ENVIRONMENTAL SITE ASSESSMENT**

**FORMER RAINIER BREWERY  
3100 AIRPORT WAY SOUTH  
SEATTLE, WASHINGTON**

**Submitted by:  
Farallon Consulting, L.L.C.  
320 3<sup>rd</sup> Avenue Northeast  
Issaquah, Washington 98027  
Farallon PN: 338-001**

April 14, 2004

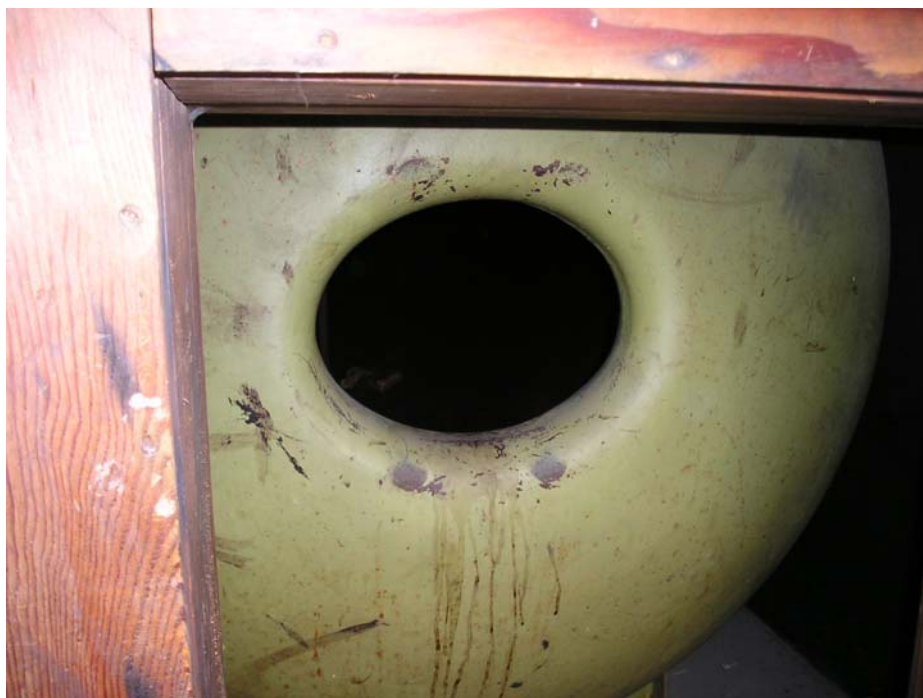
**Photograph 2:** Facing east; view of aboveground storage tank in vestibule within Building 5A.

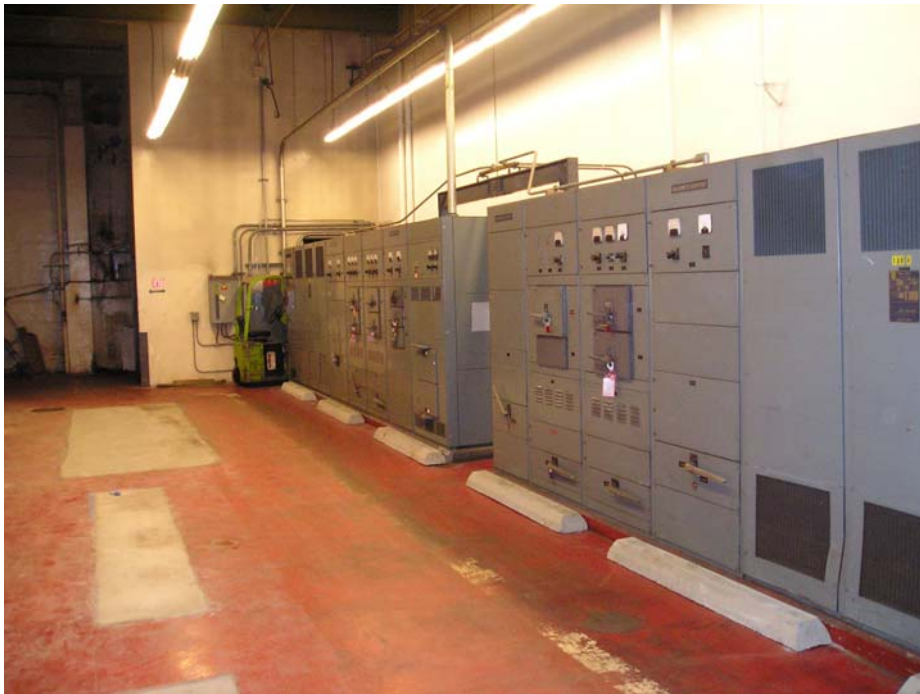
**Photograph 6:** Facing north; view of transformers on 2<sup>nd</sup> floor of Building 7; floor drain located between the transformers.

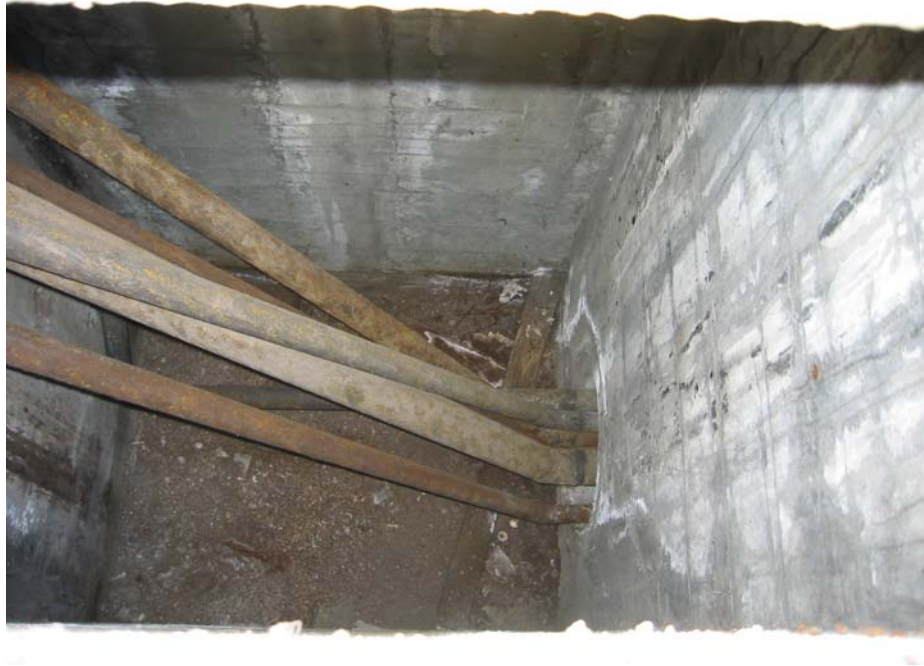
**Photograph 9:** Facing south; view of fuel piping entering Building 13 within vault in southwestern corner of the building.

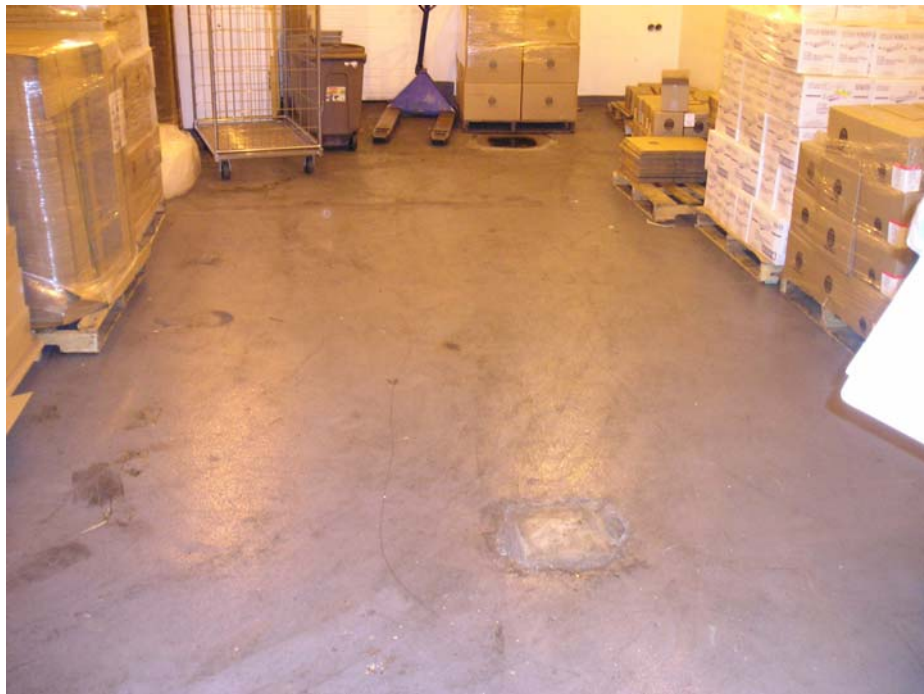
**Photograph 10:** Facing north; view of sealed floor drains on 1<sup>st</sup> floor of Building 14.

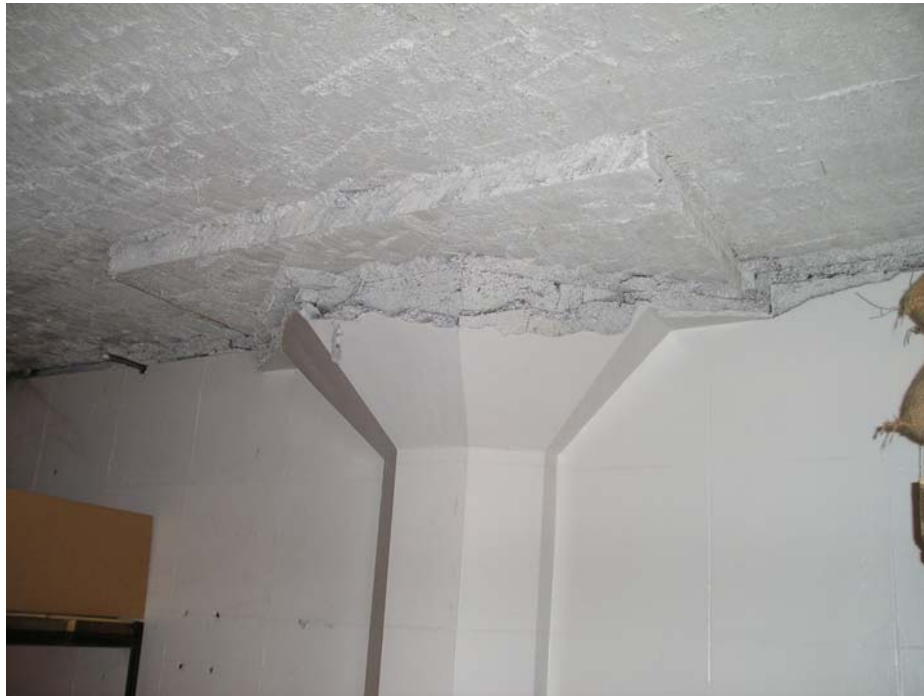
**Photograph 11:** Facing southeast; view of damaged concrete where support pillar meets ceiling on 1<sup>st</sup> floor of Building 14.

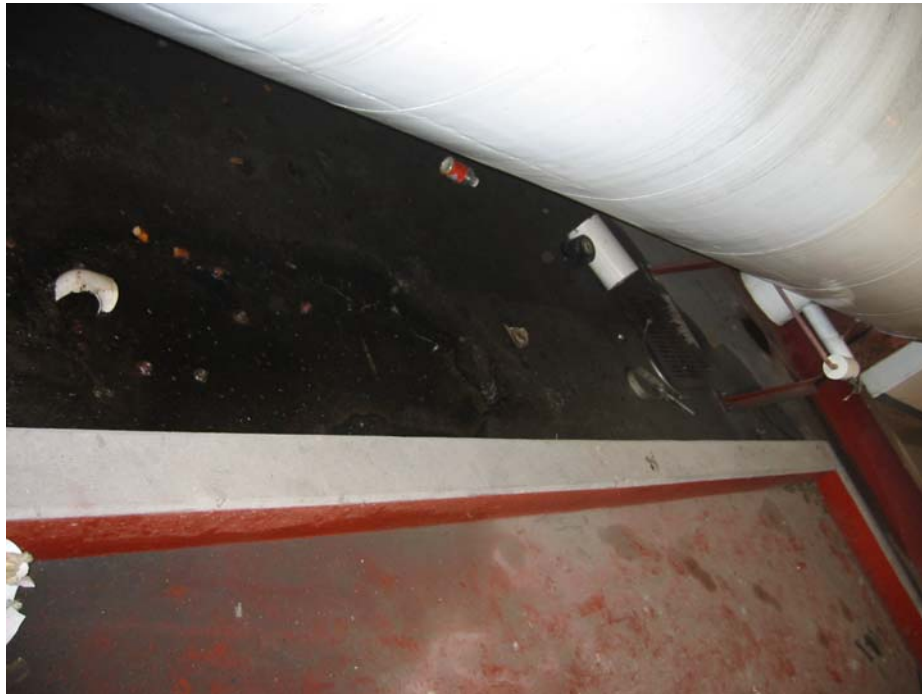
**Photograph 12:** Facing northeast; view of pooled oil beneath aboveground storage tank on 2<sup>nd</sup> floor of Building 14.

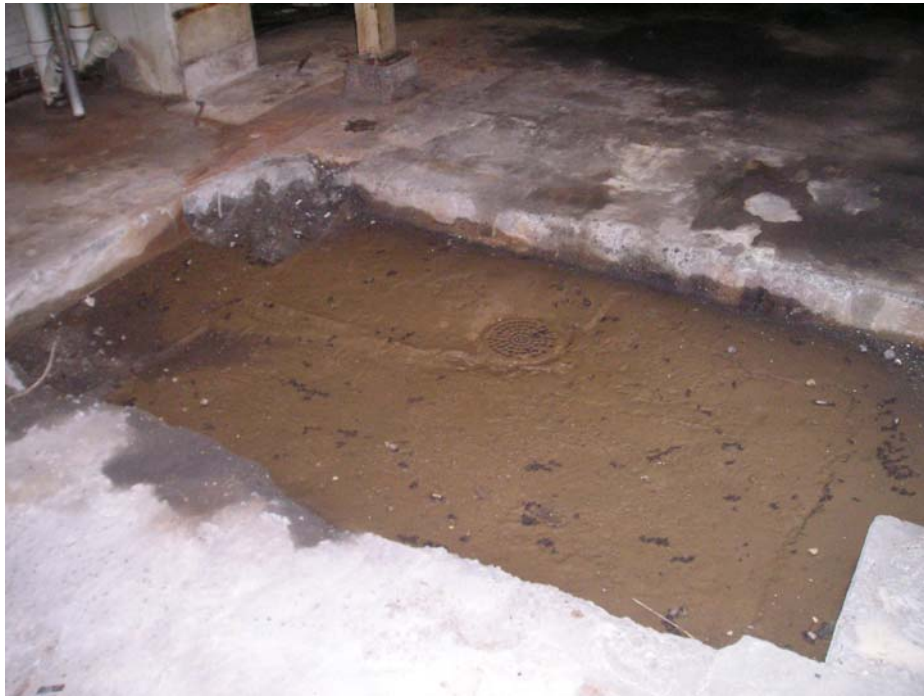
**Photograph 15:** Facing northwest; view of recessed pit and floor drain on 1<sup>st</sup> floor of Building 21.

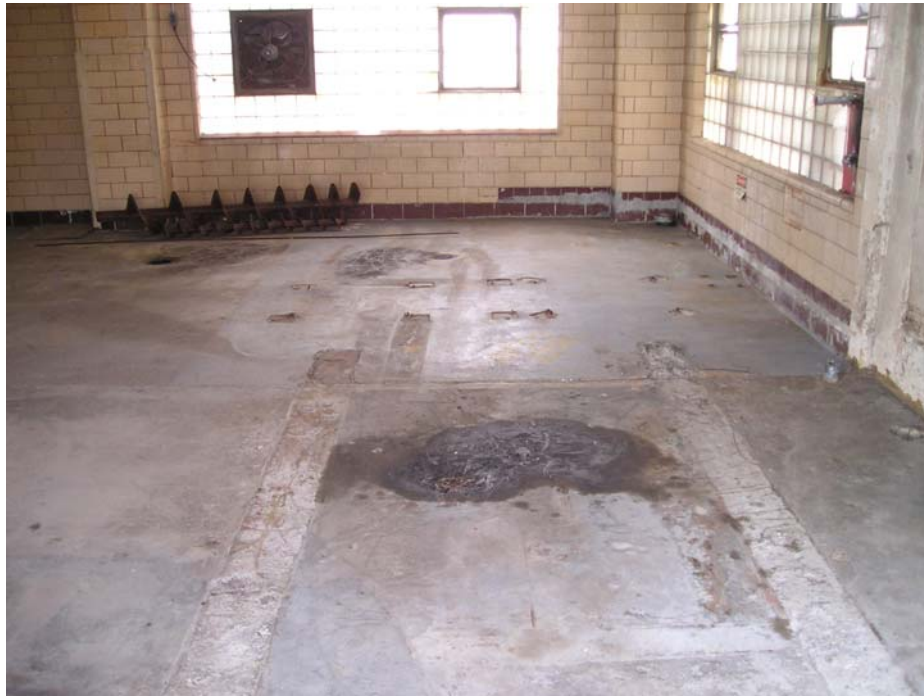
**Photograph 17:** Facing west; view of staining around drain on 6<sup>th</sup> floor of Building 21.

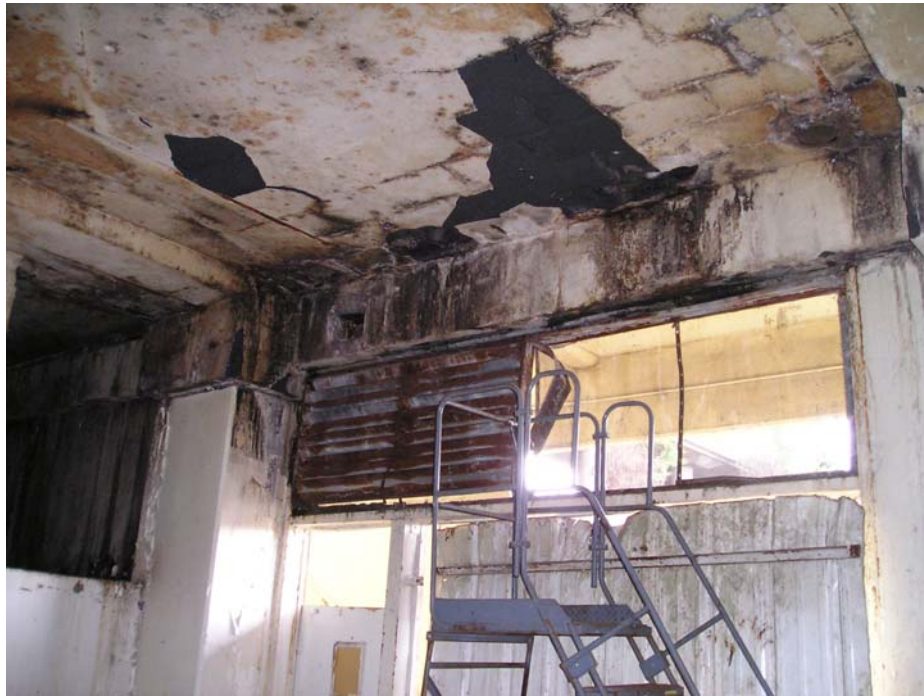
**Photograph 18:** Facing southeast; view of staining on wall, ceiling, and vent plenums on 2<sup>nd</sup> floor of Building 25, near rear exit.

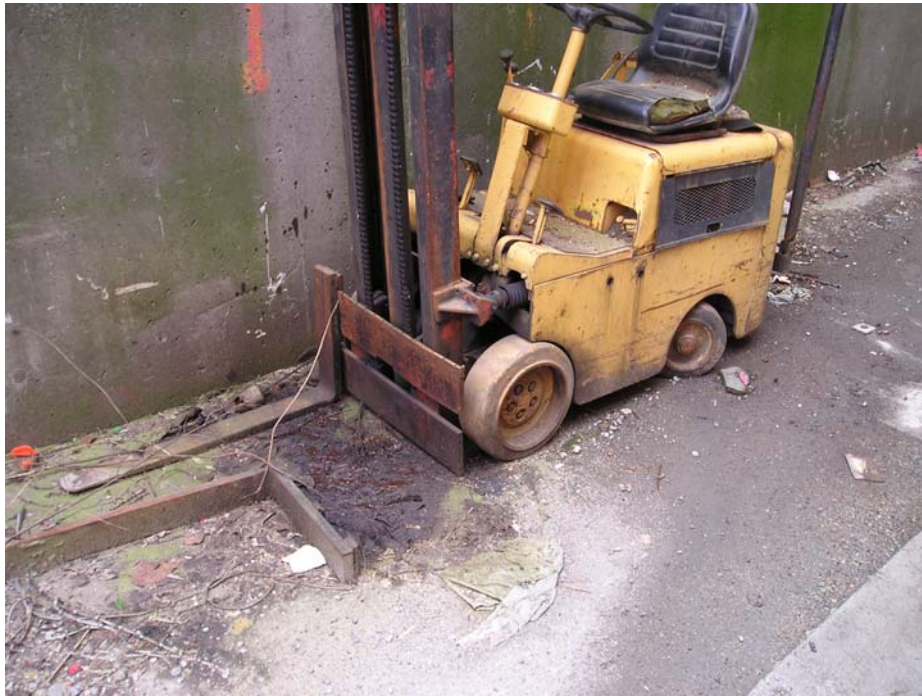
An apparently abandoned forklift was observed adjacent to the retaining wall beneath Building 21 (Photograph 20). The forklift appeared inoperable, and included disconnected hydraulic hoses and dilapidated mechanical systems. A storage vessel was observed adjacent to Building 20 (Photograph 21). A 2- by 3-foot pool of oil was observed on the asphalt adjacent to a disconnected hydraulic hose adjacent to the forklift. The storage vessel was located across the driveway from the forklift, adjacent to an access door to Building 20. Apparent oil staining was observed on the vessel, and an approximate 1- by 1-foot area of surficial staining was observed on the asphalt beneath the vessel.

Farallon observed asphalt stained with oil adjacent to an apparently decommissioned forklift and an abandoned storage vessel located adjacent to the driveway beneath Building 21. Although the stained area was small, Farallon was unable to ascertain what quantity of material had been released in the area or if it had penetrated the asphalt. Based on the limited size of the oil stains on the asphalt surface, these features do not represent a recognized environmental condition at the Site.

**Photograph 20.** Facing southeast; view of abandoned forklift in driveway beneath Building 21.

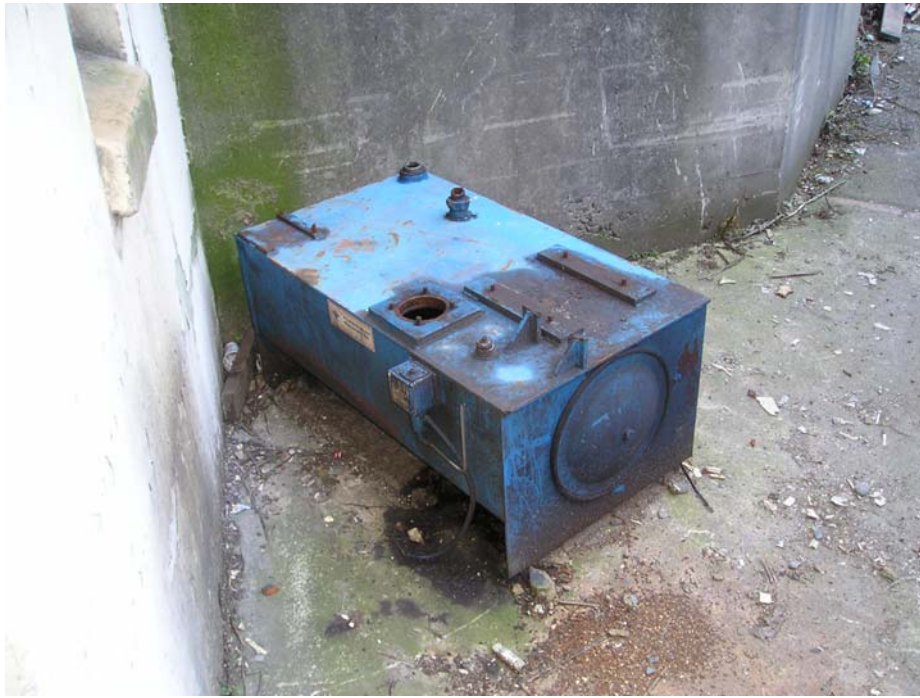
**Photograph 21.** Facing northwest; view of abandoned storage vessel located adjacent to the entrance to Building 20.
